Let's Get the Lead Out! Help Us Protect Your Health

Brook Forest Water District, CO0130010

Water Service Line Customer Survey

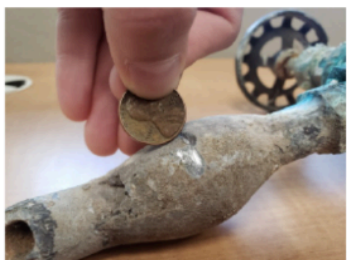
Lead pipe

Magnets do not stick to lead pipes.

If you scratch the pipe with a coin, the scraped area will appear shiny silver and flake off.
